Home Inspection Report For Joe Homeowner 1234 Anystreet, Anytown, IL 60600

All American Home Inspection Services, Inc.

10/26/2006

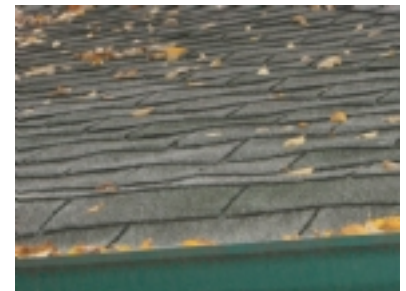
INFORMATION - The shingles are curled. In my opinion this indicates that the shingles are in the later stage of their expected life span. I recommend you start to prepare for a new roof.

Picture Date:10/26/2006 Comments:
Curled roofing

INFORMATION - In my opinion, based on the condition of the roofing the existing roof should be removed prior to installation of a new roof.

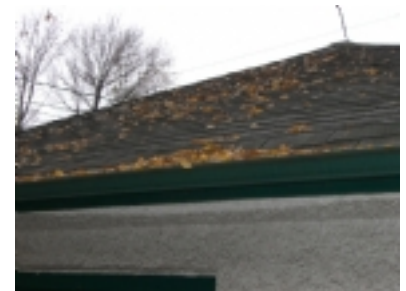
MAINTENANCE - Debris is blocking water flow from the gutters. In my opinion this can cause various damage including the increased potential for water leakage into the home if not corrected and cleaned out.

Picture Date:10/26/2006 Comments:
Gutters clogged with leaves.

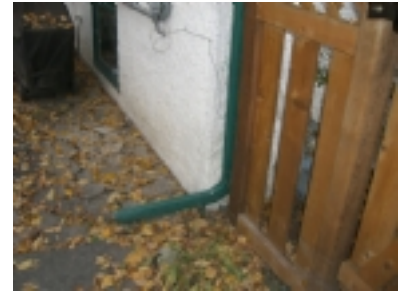
REPAIR or REPLACE - The downspout discharge drains close to the house. As a rule of thumb, a minimum drainage of six feet from the house is recommended. In my opinion when drainage is closer than 6 feet there is an increased potential for water to go back to the foundation and result in water leakage into basements and crawl spaces. Water leakage can cause various problems and damage including damaging drywall, plaster, paneling, flooring and similar. Water leakage can also lead to mold problems. I recommend that you contact a qualified contractor to mitigate the situation if possible.

Picture Date:10/26/2006 Comments: downspout is draining too close to the house.

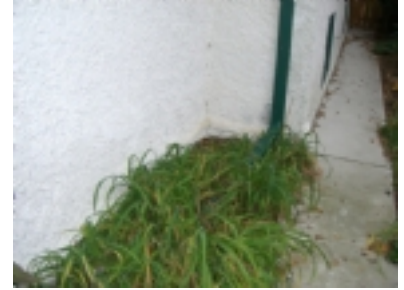
Picture Date:10/26/2006 Comments: This downspout in front on East side drains next to the house.

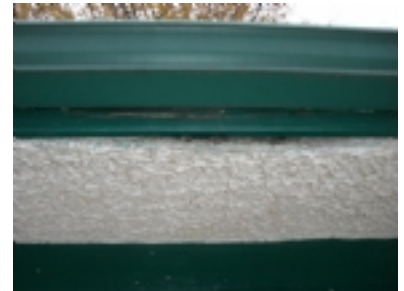
REPAIR or REPLACE - Sections of the soffit is loose. In my opinion this can increase the chances for further damage to the building. I recommend that you contact a qualified contractor to mitigate the situation.

Picture Date:10/26/2006 Comments: Soffit on garage is loose.

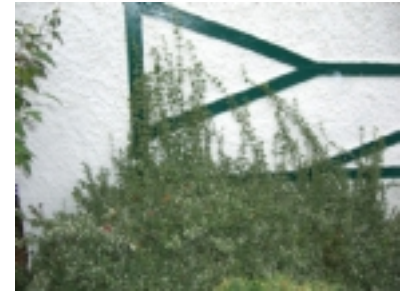
MAINTENANCE - Vines are growing on the walls of the house. In my opinion vines give access to insects and moisture damage to the house. I believe this can damage the building if it is not removed. Appropriate corrective action is recommended by a qualified contractor.
necessary.

Picture Date:10/26/2006 Comments:
Vines growing on stucco wall in front.

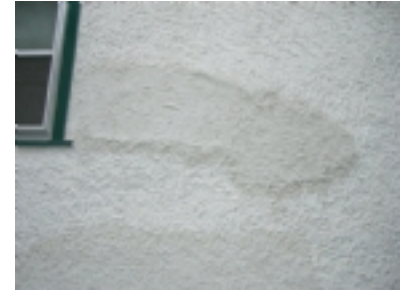
INFORMATION - There has been one or more repairs to stucco walls on this house. I cannot determine the extent of damage previously or if the repairs were made professionally. I would ask for any information about past repairs to the home including the stucco.

Picture Date:10/26/2006 Comments:
Wall repair made to stucco.

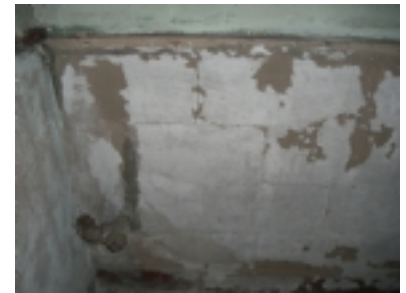
REPAIR or REPLACE - Cracking observed in the foundation. Cracked foundations can lead to water seepage and related water damages. Water leakage can cause various problems and damage including damaging drywall, plaster, paneling, flooring and similar. Water leakage can also lead to mold problems. Cracking can be a symptom of structural issues. Appropriate corrective action is recommended by a qualified contractor.

Picture Date:10/26/2006 Comments:
Cracks in foundation wall in basement.

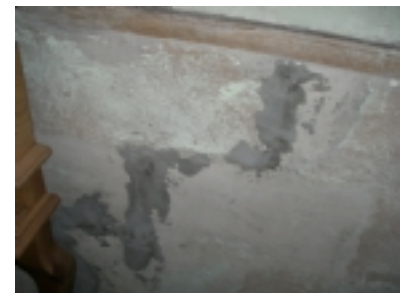
Picture Date:10/26/2006 Comments:
Patching of cracks in basement foundation wall.

INFORMATION - Indicators of past repairs are present. I recommend you request any and all information regarding these repairs. It is not within the scope of this inspection to determine the appropriateness or effectiveness of any repairs or their sustainability.

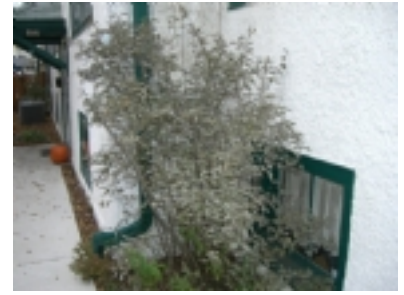
MAINTENANCE - Bushes are touching the building. In my opinion this can lead to insect and water damage to the building. I recommend that you contact a qualified landscaping contractor to mitigate the situation.

Picture Date:10/26/2006 Comments: Bush touching house.

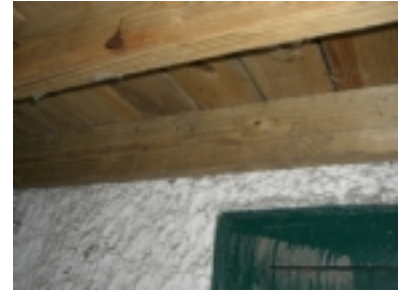
SAFETY - The ledger board does not appear properly attached to the building at back porch. In my opinion, this can result in a ledger board failure and a collapse. This is considered an unsafe condition and immediate repair is recommended by a qualified contractor.

Picture Date:10/26/2006 Comments: Ledger board has only been nailed. Lag bolts should be used to fasten ledger to house.

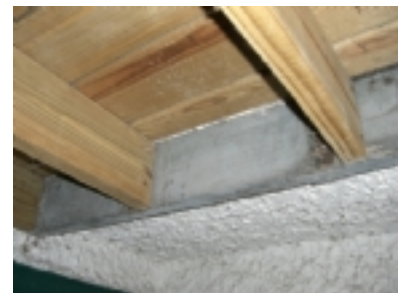
SAFETY - Joist hangers are not installed. Lack of joist hangers can result in a structural problems and an unsafe condition. Correction by a qualified contractor is recommended.

Picture Date:10/26/2006 Comments: No joist hangers installed.

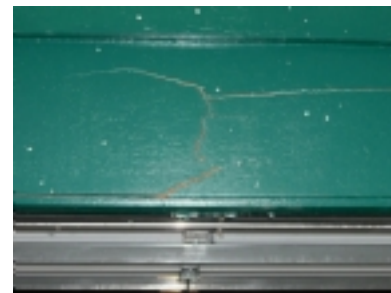
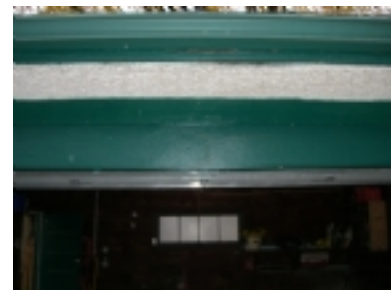
The overall condition is acceptable for the overhead door but there is a cracked board below the header. This board is not a structural item but should be watched to make sure it doesn't fall and hurt someone.

Picture Date:10/26/2006 Comments:
Cracked board under header at garage
overhead door.
2 pictures.

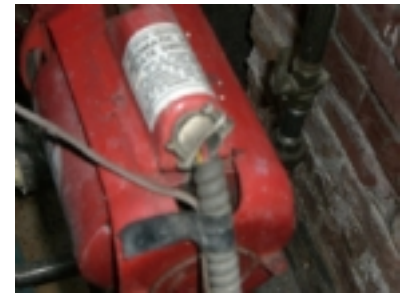
SAFETY - Exposed line voltage wiring is present at the heating equipment. In my opinion this indicates improper wiring methods and is an increased electrical shock and fire hazard. Appropriate corrective action is needed by a qualified contractor.

Picture Date:10/26/2006 Comments: BX connector needs to be reconnected.

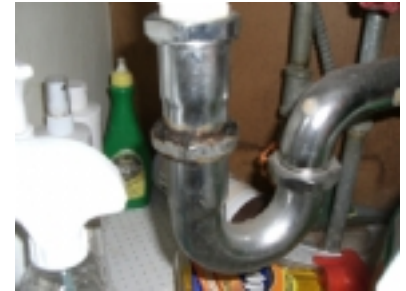
REPAIR or REPLACE - The sink trap is corroded. Replacement is needed before leaking develops. Corrective action is needed by a qualified plumber.

Picture Date:10/26/2006 Comments: Corroded trap

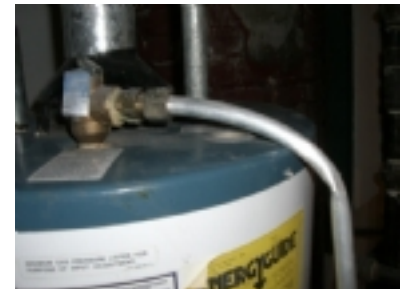
SAFETY - The temperature / pressure relief valve (TPR) is an important safety feature and can prevent explosions in the event of a malfunction. The TPR valve extension pipe is too small (wrong size) and may not be able to safely discharge water in the event of an emergency or malfunction. In my opinion this is an explosion hazard and properly sized & installed extension pipe is needed by a qualified contractor.

Picture Date:10/26/2006 Comments: Pipe is too small and has a kink in it.

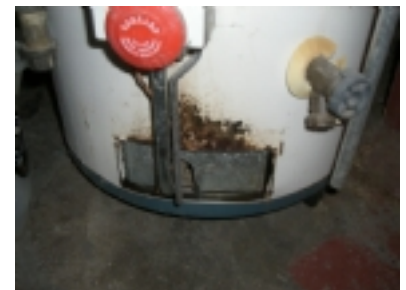
INFORMATION - There is rust at the access door to the water heater. I cannot determine what the cause of this is. When changing the TPR valve ask the plumber if he can identify the problem which might be causing rust to develop in this area.

Picture Date:10/26/2006 Comments: Rust

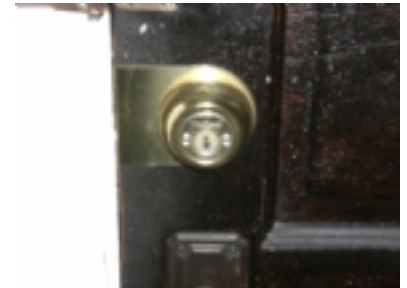
SAFETY - Door leading to the exterior at back is equipped with a doubled cylinder keyed dead bolt (needs a key from the inside of the house). In my opinion, this is a serious safety hazard in regards to entrapment and emergency egress. Appropriate corrective action is needed by a qualified locksmith.

Picture Date:10/26/2006 Comments:
Double cylinder deadbolt.

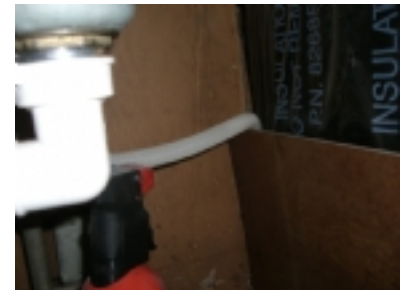
REPAIR or REPLACE - The drain pipe from the dishwasher does not have a loop in the drain line. In my opinion this has the potential for drain water to flow backwards to the dishwasher and possibly cause contamination. Corrective action is recommended by a qualified appliance technician.

Picture Date:10/26/2006 Comments: Smaller white plastic pipe to the right should have a loop in it and be above the drain on the sink to prevent water from draining back into the dish washer.
